WARTIME REPORT

AN INVESTIGATION OF A THERMAL ICE-PREVENTION SYSTEM
FOR A C-46 CARGO AIRPLANE

III - DESCRIPTION OF THERMAL ICE-PREVENTION EQUIPMENT
FOR WINGS, EMPENNAGE, AND WINDSHIELD

By Alun R. Jones and Ray J. Spies, Jr.

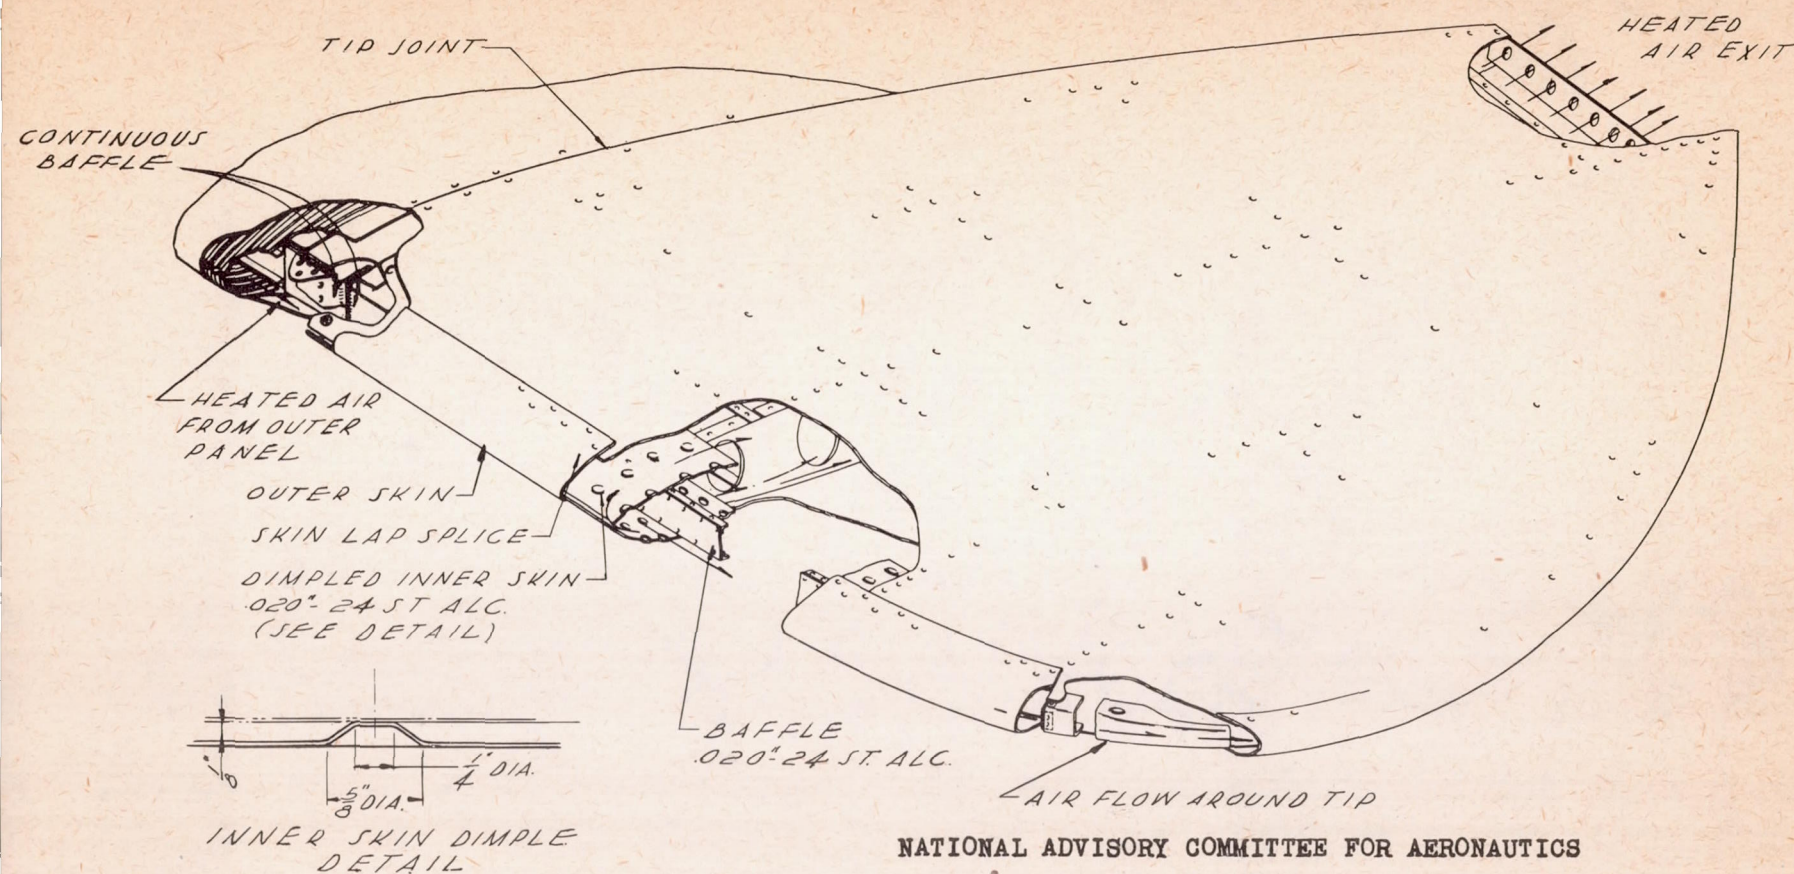
FIGURE 15- WING TIP OF C-46 AIRPLANE AS REVISED FOR
THERMAL ICE PREVENTION

The revisions to the wing tips are shown in figure 15. The type of leading-edge construction is similar to that employed in the case of the wing outer panel with the exception that the corrugated inner skin is replaced by a dimpled type which is more adaptable to the double-contour forming necessary in the wing-tip revisions. The baffle plates in the wing outer panel and tip are located at the same chord station at the tip joint, thus extending the spanwise distribution duct to the extreme end of the wing tip.

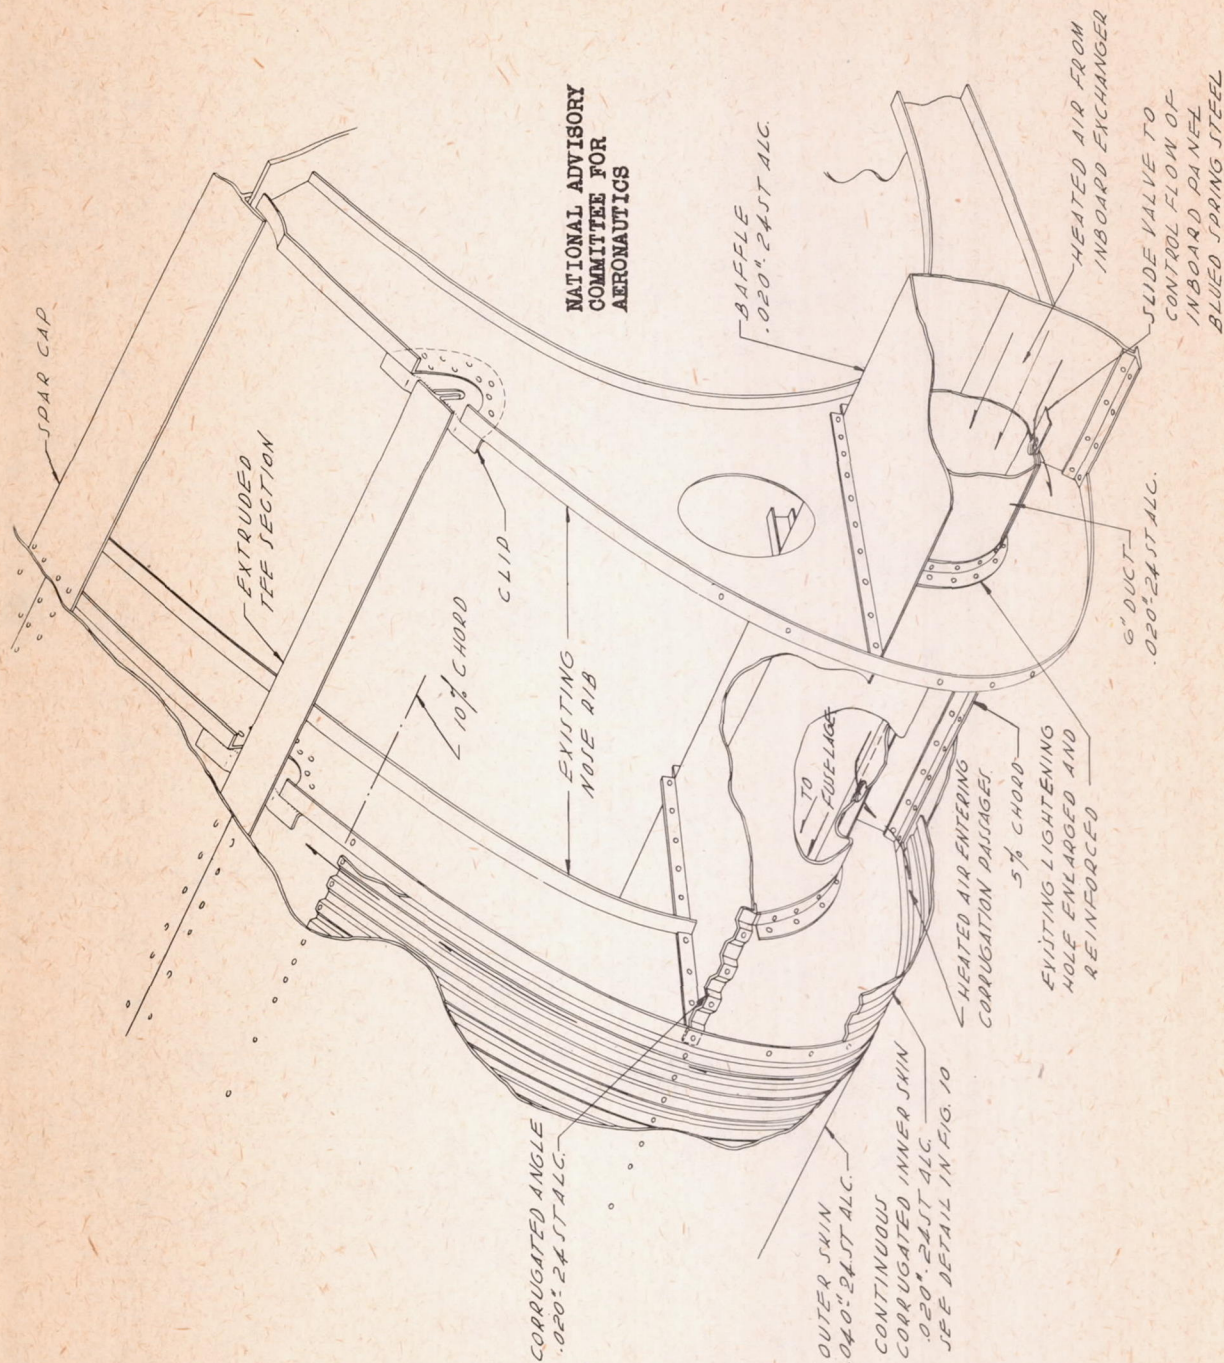
FIGURE 16—TYPICAL WING INBOARD-PANEL LEADING-EDGE SECTION AS REVISED FOR THERMAL ICE-PREVENTION, C-46 AIRPLANE

The thermal ice-prevention system for the leading edge of the inboard panels is shown in figure 16. The corrugated

inner skin, in this case, extends in a continuous sheet from 5 percent chord on the wing lower surface to 10 percent chord on the upper surface. The heated air for the system is obtained from the supply ducts from the inboard exchangers through the installation of slide valves on the upper surface of the ducts. The heated air is caused to flow through the corrugation passages, from bottom to top, by surrounding the supply duct with a baffle. The web of the inboard-panel front spar is highly stressed and therefore no holes were cut for circulation of the heated air through the interior of the wing. The air returns to the free stream through existing openings in the structure. The inboard-panel leading-edge skin, with corrugated inner skin attached, is shown during installation on the wing in figure 17. The supply duct from the left inboard exchanger and the angles with which the baffle is attached to the ribs can also be seen in figure 17.

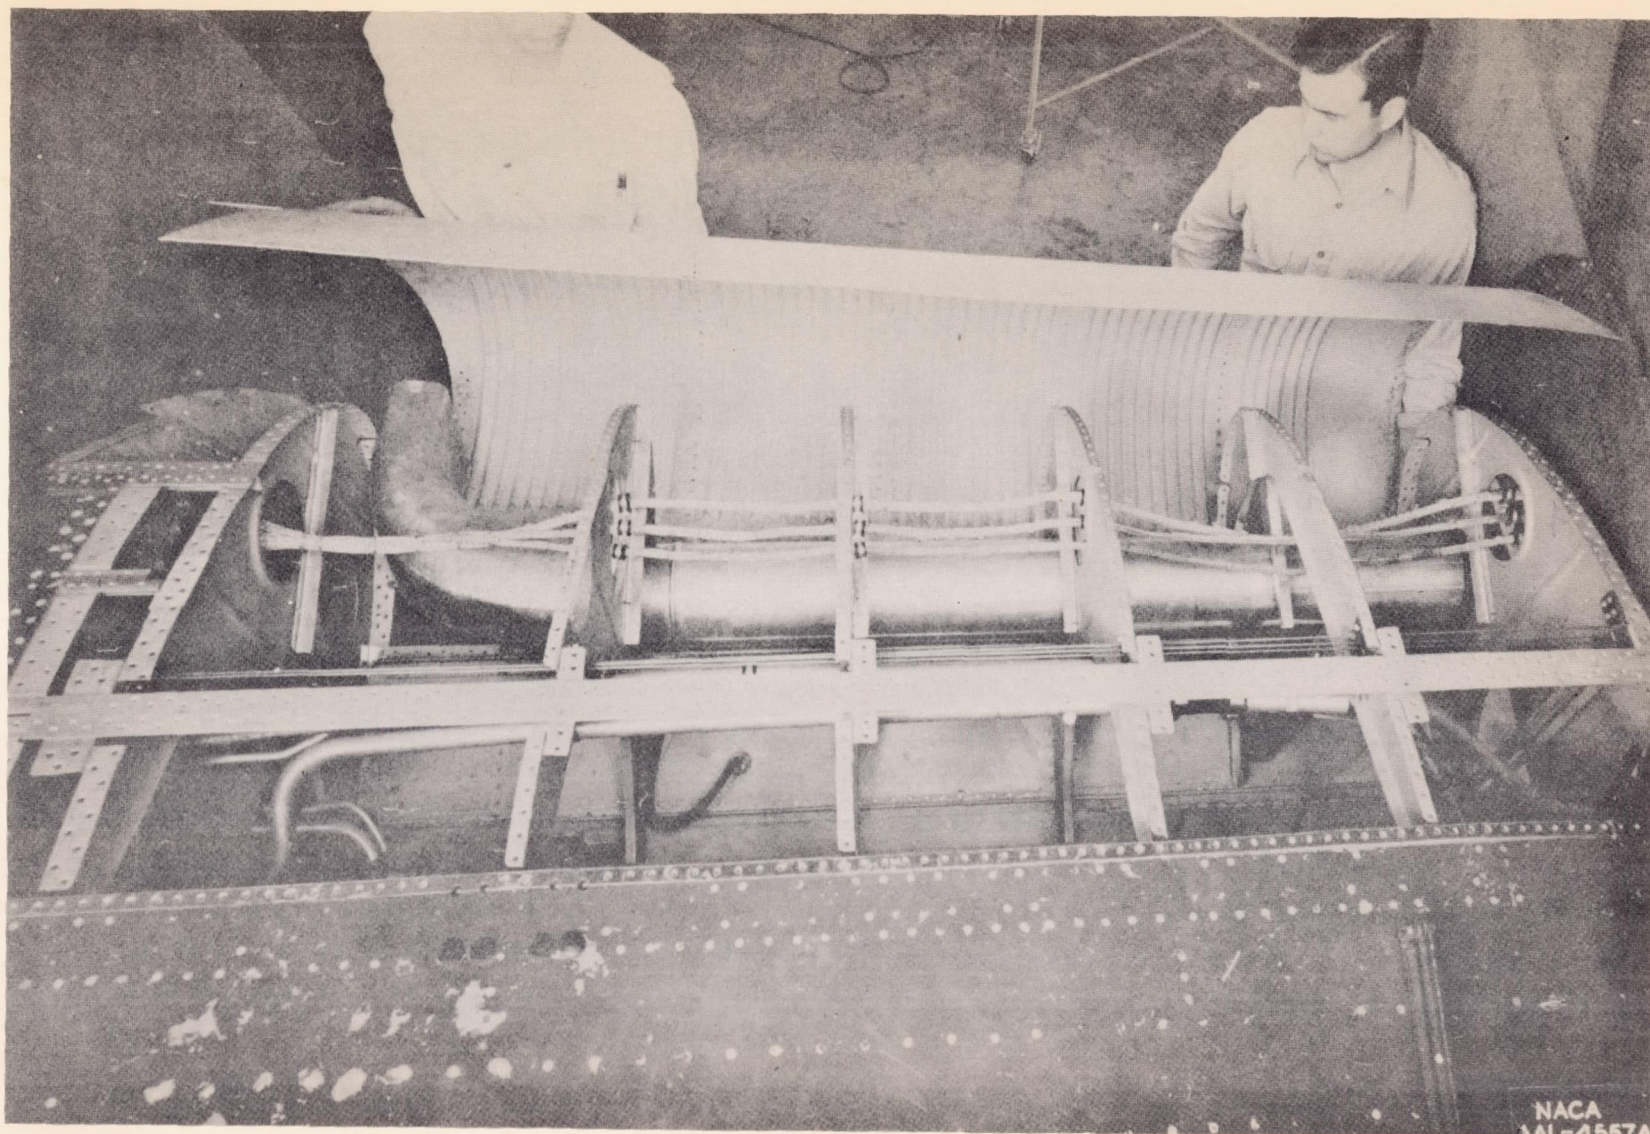
FIG. 17

Figure 17.- Rear view of inboard-panel leading edge during installation on C-46 airplane.

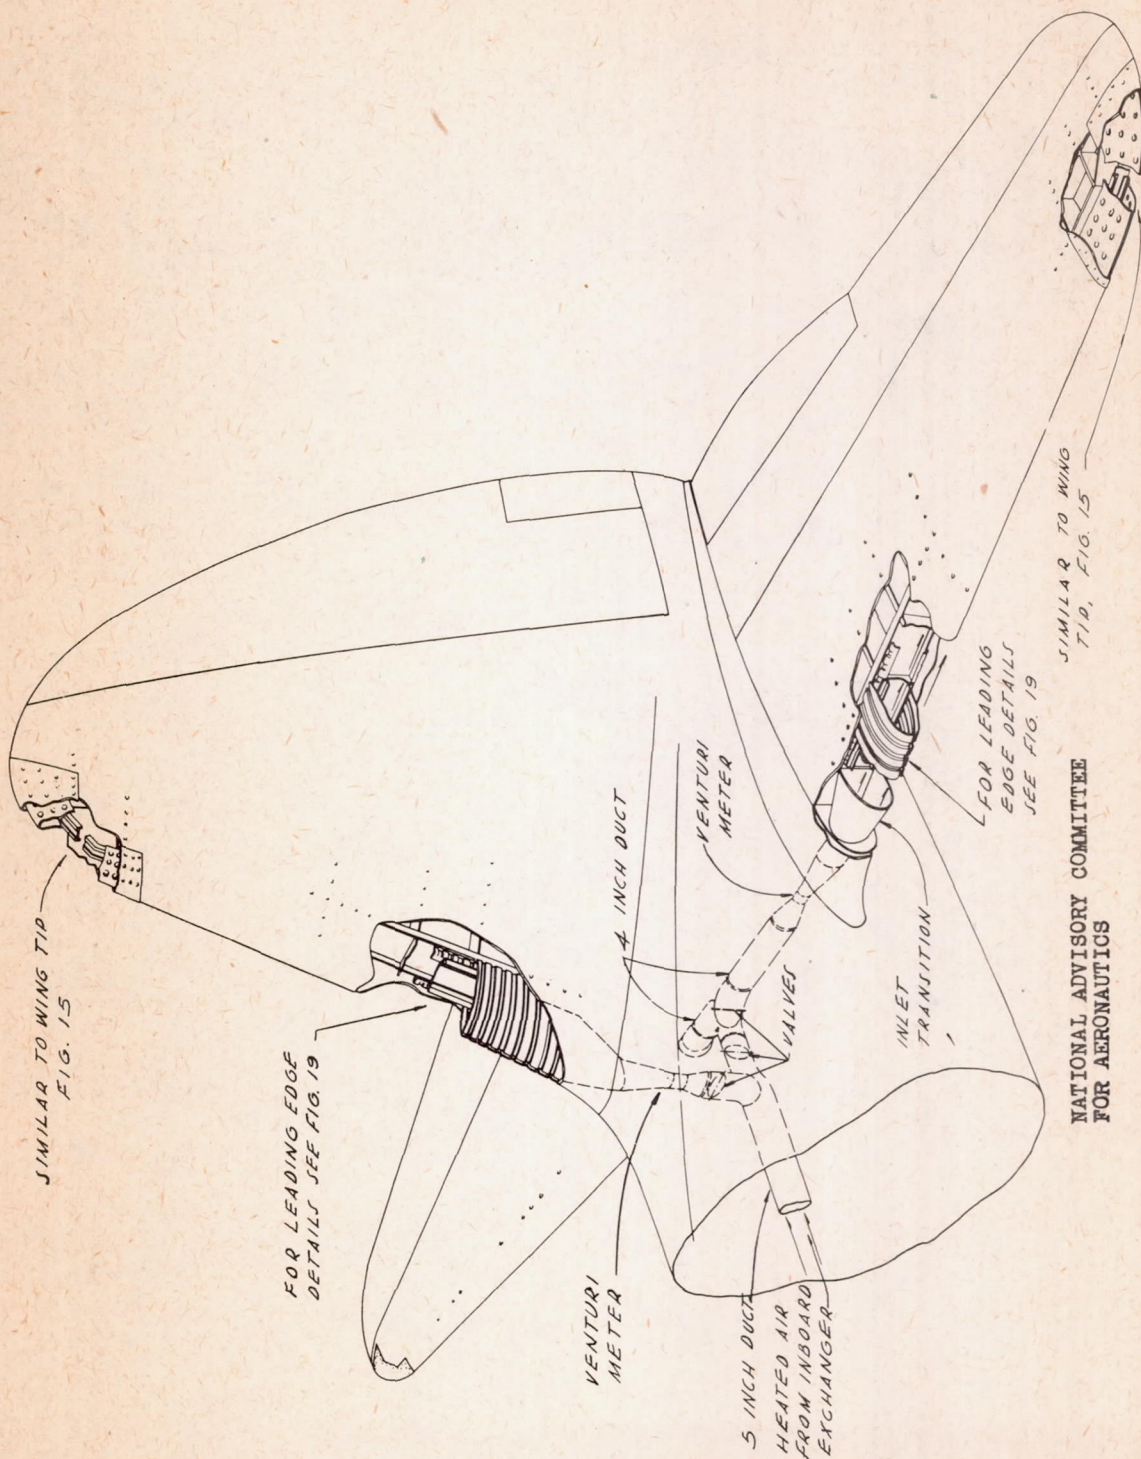
FIGURE 18.- GENERAL LAYOUT OF THERMAL ICE-PREVENTION
EQUIPMENT IN EMPENNAGE OF C-46 AIR PLANE.

The general arrangement of the thermal ice-prevention equipment in the empennage of the C-46 airplane is shown in figure 18. Distribution of the heated air between the stabilizer and the fin, and between the right and left sides of the stabilizer, is controlled by adjustment of the three butterfly valves shown in figure 18.

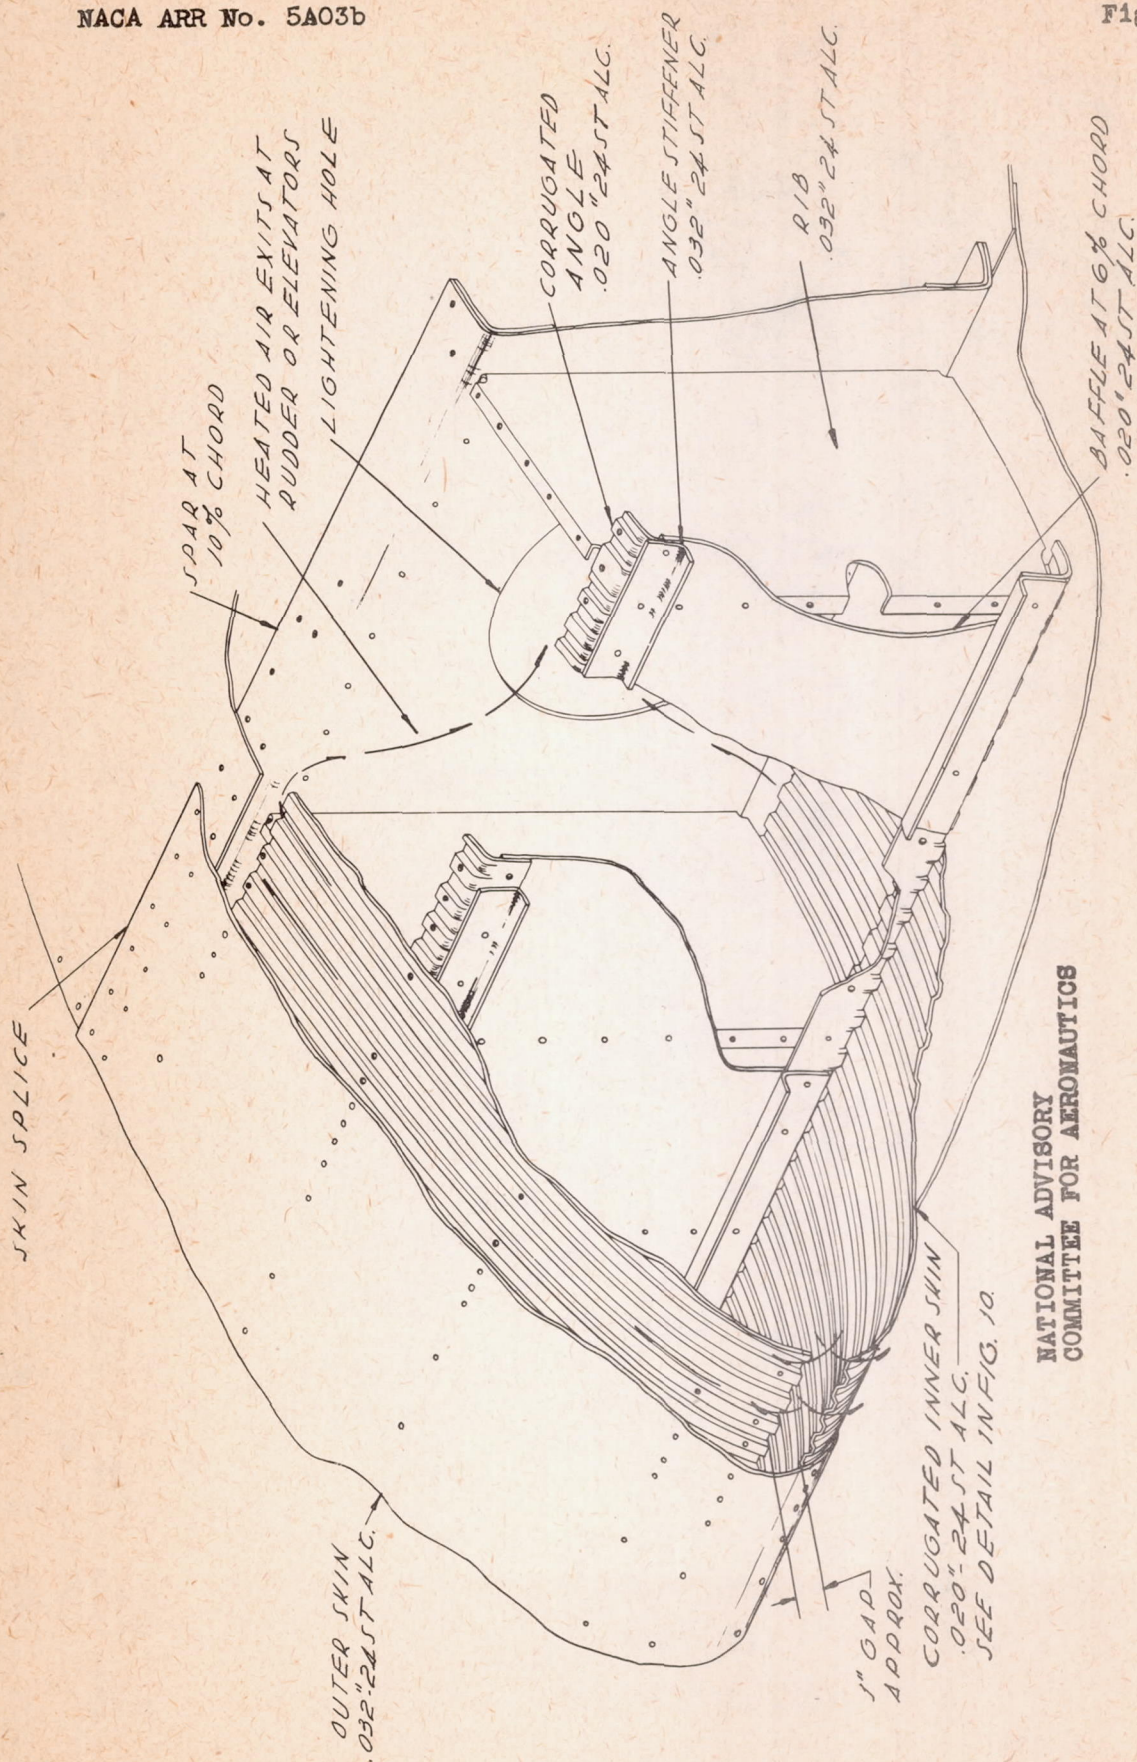
FIGURE 19 DETAILS OF FC-46 AIRPLANE STABILIZER AND FIN LEADING EDGES AS REVISED FOR THERMAL ICE-PREVENTION

The revisions to the stabilizer and the fin leading edges are identical and a typical section is shown in figure 19. The design is similar to that employed in the case of the wing outer panel. The corrugated inner skin extends rearward to 10 percent of the airfoil chord and the corrugation passages are identical to those in the wing. A rear view of the baffle plate and corrugated inner skin for the stabilizer leading edge is shown in figure 20. The completely revised leading edge prior to installation on the stabilizer is shown in figure 21. After leaving the leading-edge region, the heated air circulates through the stabilizer or fin interior and is discharged at the elevator or rudder slot. The dimpled-skin and continuous-baffle type of construction employed in the wing-tip revisions was also utilized in the case of the stabilizer and fin tips (figs. 15 and 18). The modified leading edge of the fin tip is shown in figure 22 during construction. The baffle has been bent away from its attachment angles in order to show a larger portion of the dimpled skin and the air gap at the leading edge. The revised leading edge prior to installation on the fin is shown in figure 23.

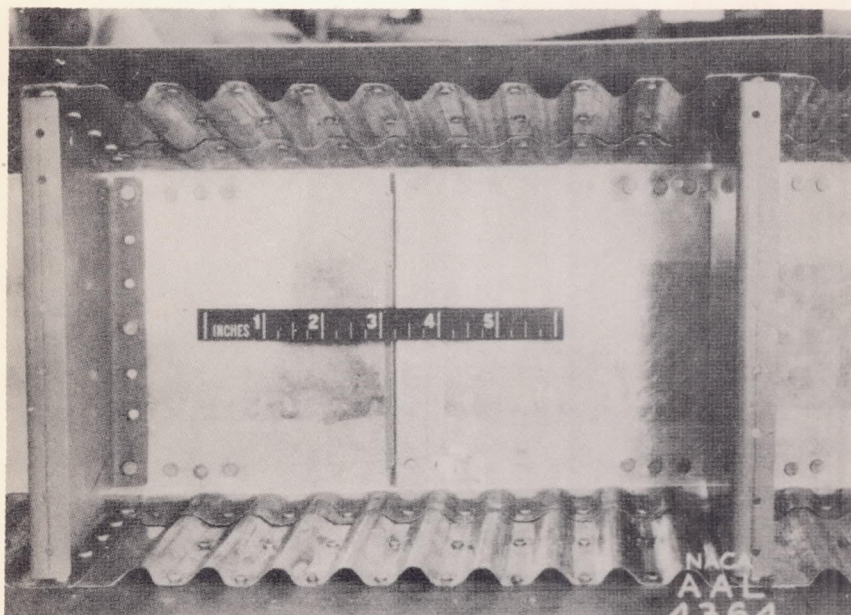
Figure 20.- Rear view of baffle plate and corrugated inner skin for stabilizer leading edge, C-46 airplane.

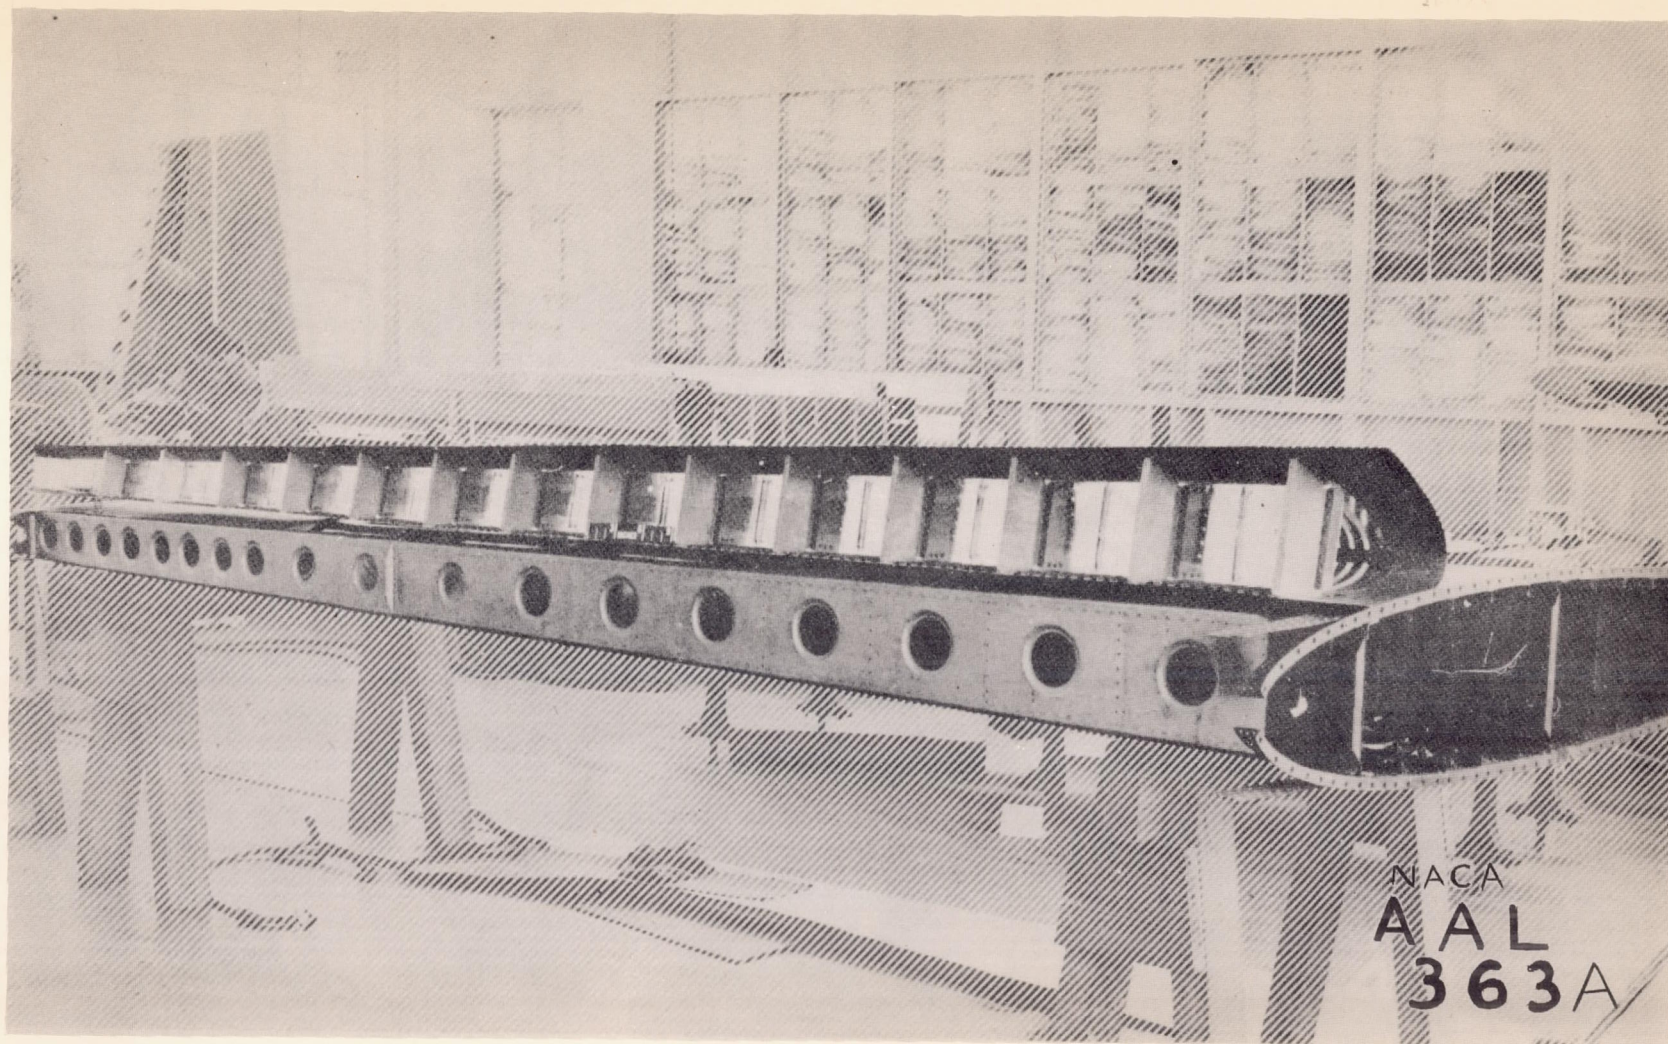
Figure 21.- Revised leading edge prior to installation on stabilizer, C-46 airplane.

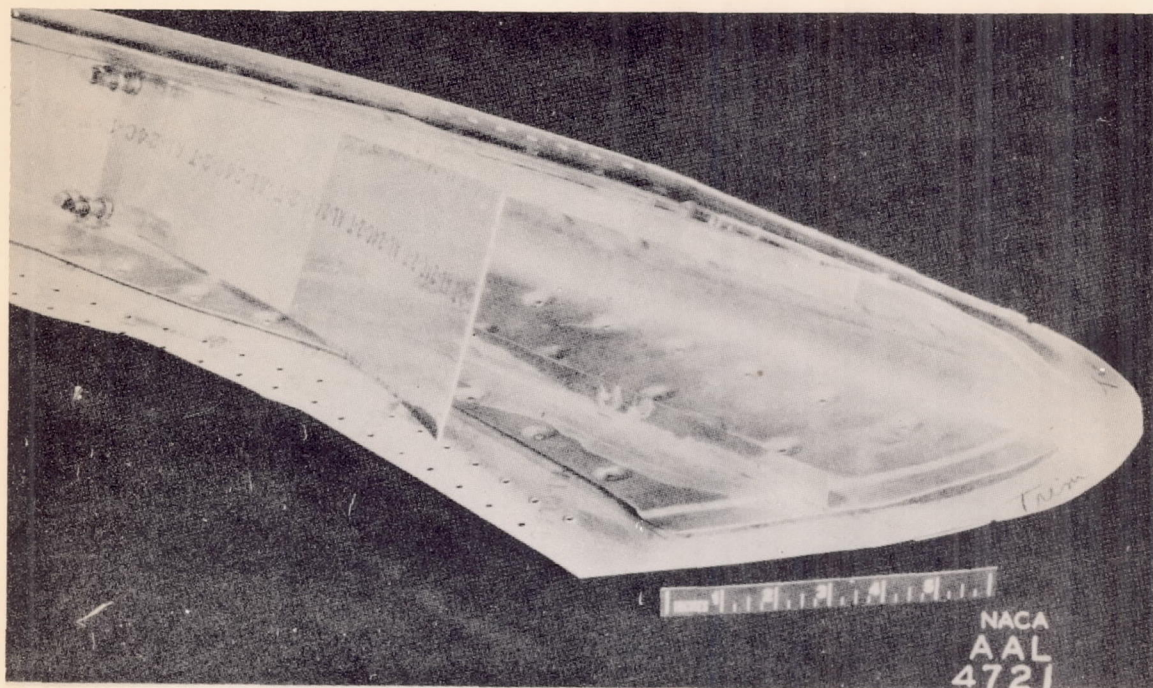
Figure 22.- Revised leading edge of fin tip showing baffle plate and dimpled-skin details, C-46 airplane.

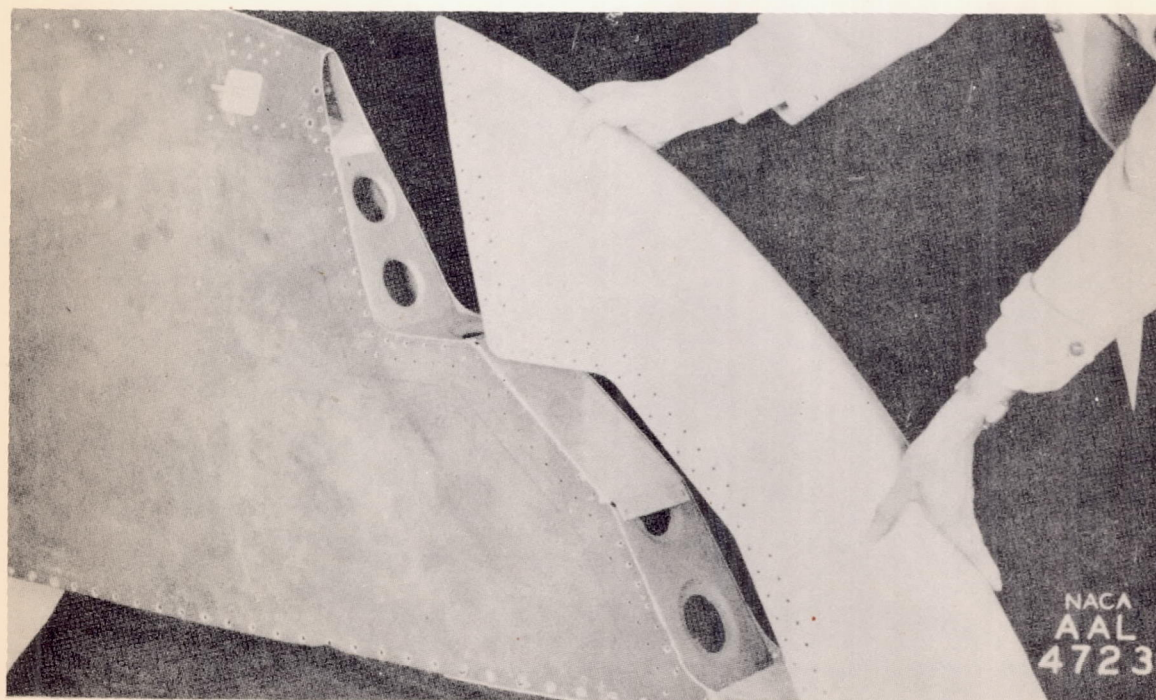
Figure 23.- Revised leading edge for fin tip prior to installation, C-46 airplane.

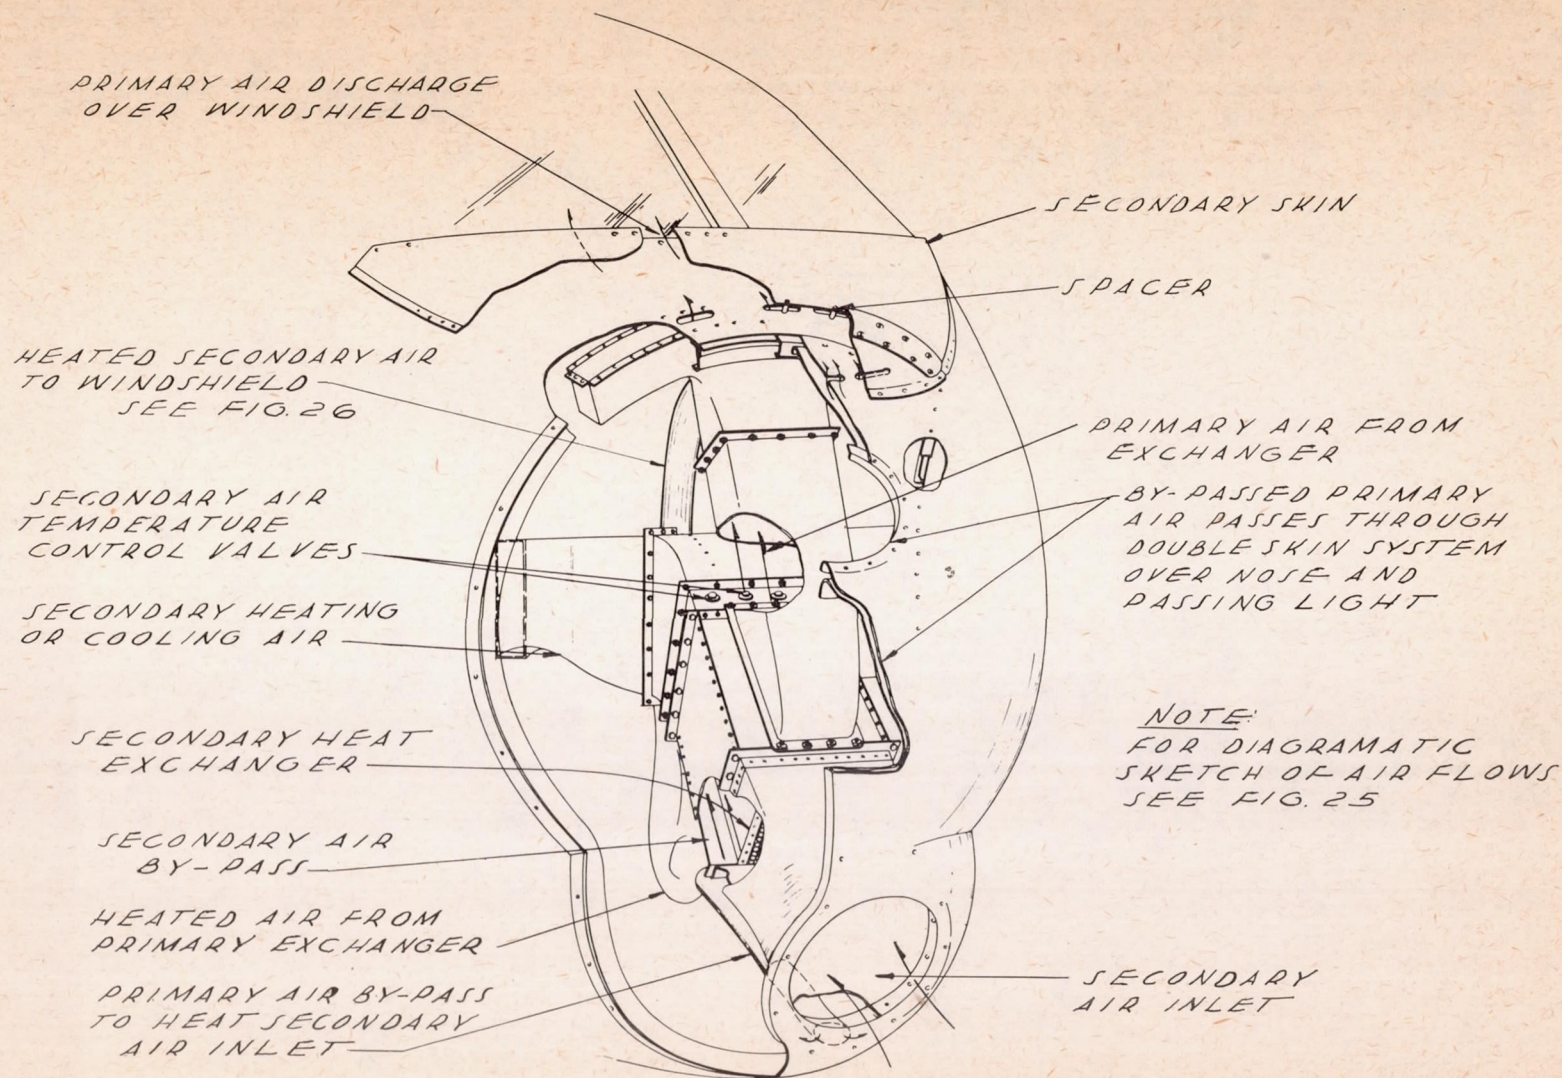
FIGURE: 24 - DETAILS OF HEAT-EXCHANGER INSTALLED IN NOSE OF C-46 AIRPLANE TO PROVIDE SECONDARY HEATED AIR FOR WINDSHIELD AND COCKPIT HEATING.

A secondary heat exchanger was installed in the nose of the airplane to provide heated air for cockpit and windshield heating as shown in figure 24. A schematic drawing indicating the flow of air through the installation is presented in figure 25. Secondary air was used for the heating medium in preference to primary air in order to minimize the possibility of carbon-monoxide poisoning of the flight crew. The secondary exchanger is of the all-aluminum, flat-tube type similar to current intercooler designs. The design analysis of the windshield-heating requirements (reference 1) indicated that the secondary air would not have sufficient heat capacity for windshield protection, and therefore provision was made to discharge the primary air from the secondary exchanger over the outer surface of the windshield for additional heating. This was accomplished by attaching a secondary skin to the fuselage surface immediately forward of the windshield. The gap between the fuselage and secondary skins is about $1/4$ inch. Primary air from the secondary exchanger is introduced into this space through slots in the fuselage skin and is discharged at the base of the windshield through an opening $1/4$ inch by 58 inches along the lower edge of the windshield. An additional portion of the primary air is bypassed around the exchanger and employed to heat the regions surrounding the secondary-air inlet and passing light. The secondary air enters the system at the airplane nose and, by means of the valves located immediately behind the exchanger, the pilot and copilot can control the mixture temperature of the cockpit ventilating air. When windshield heating is desired, the heated secondary air from the exchanger can be directed to the blower by operation of the two valves shown in section A-A of figure 25.

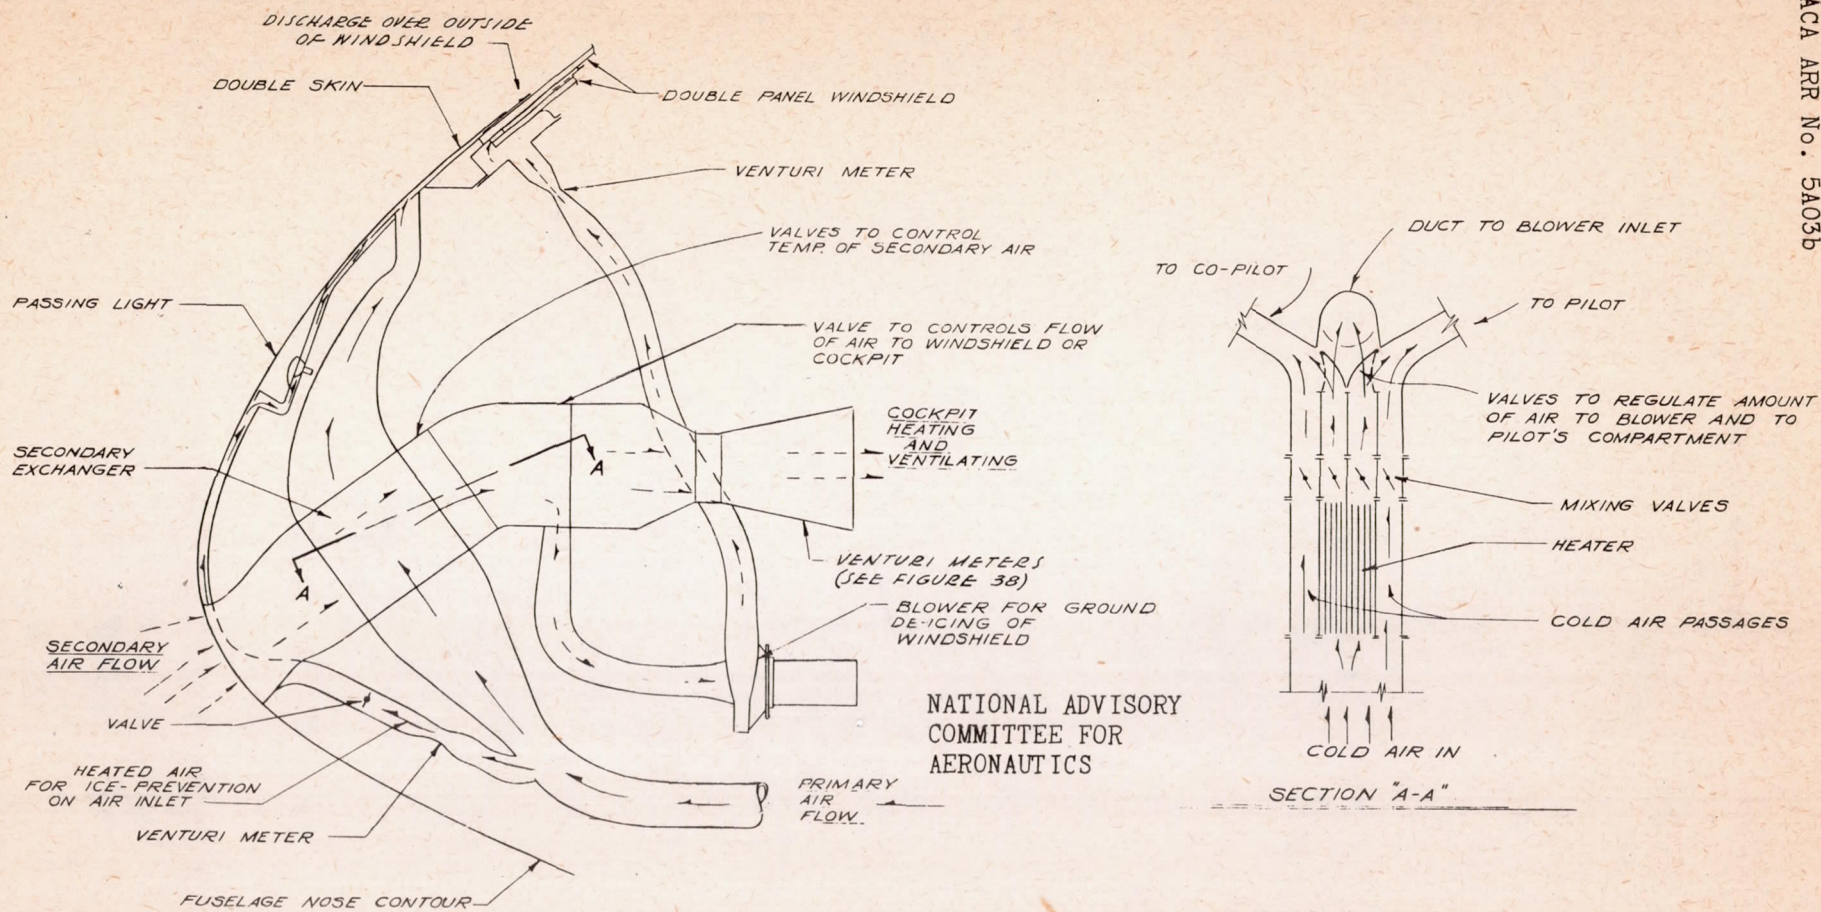
FIGURE 25.— PRIMARY AND SECONDARY AIR FLOW FOR SECONDARY HEAT EXCHANGER INSTALLATION IN C-46 AIRPLANE.

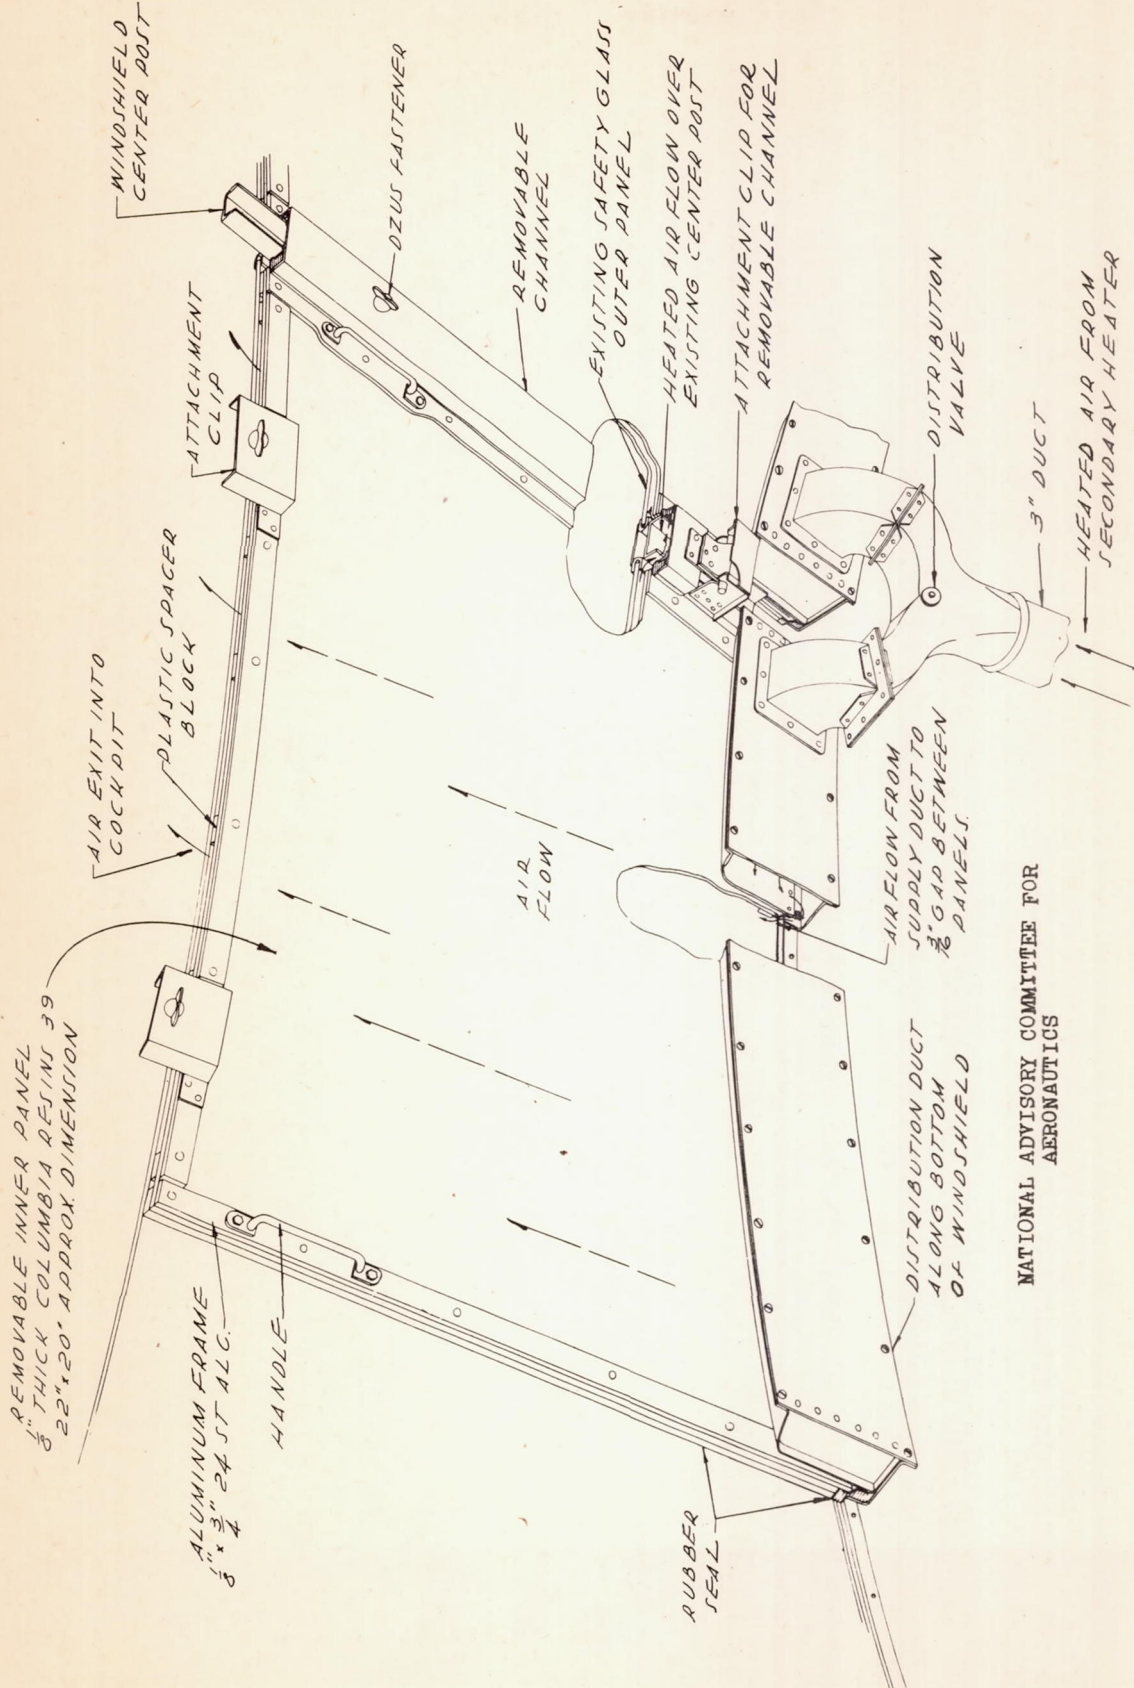
FIGURE 26 INSIDE VIEW OF PILOT'S HEATED WINDSHIELD IN C-46 AIR PLANE
CO-PILOT'S WINDSHIELD IS PROVIDED WITH SIMILAR INSTALLATION

The internal thermal ice-prevention system for the windshield is shown in figure 26. The installation for each side of the windshield consists of an inner removable panel spaced $3/16$ inch from the existing outer panel and an air-distribution duct along the bottom of the windshield. After passing through the gap between the inner and outer panels, the heated air is discharged into the cockpit at the top of the inner panel. Previous experience with similar air-heated-windshield installations has shown that ice tends to form on the unheated center post and extend over the windshield area. In the present design, therefore, heating of the center post was provided by the installation of a removable channel which formed a chamber for circulation of the heated air as shown in figure 26.

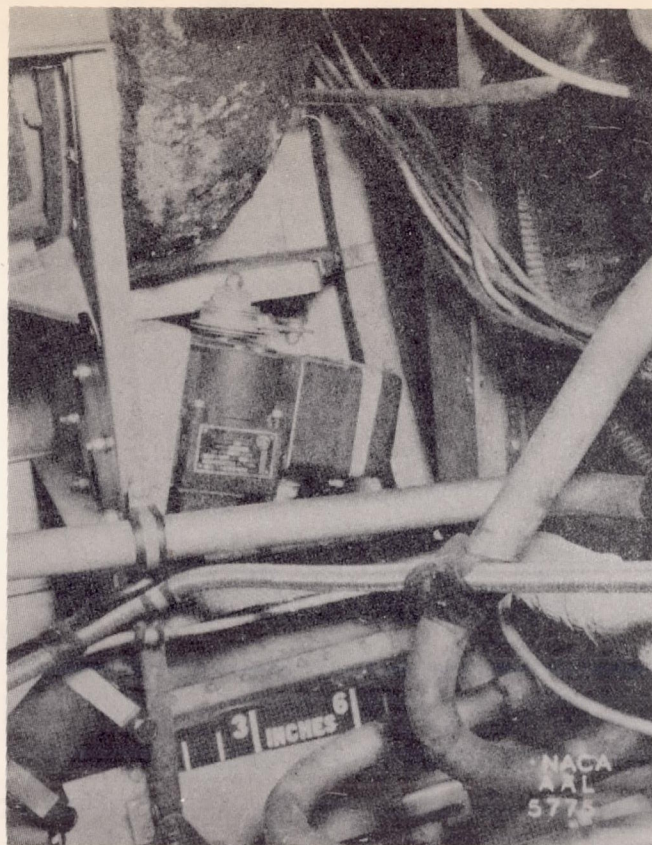
Figure 27.- Discharge-valve control motor installed in outboard side of left nacelle, C-46 airplane.

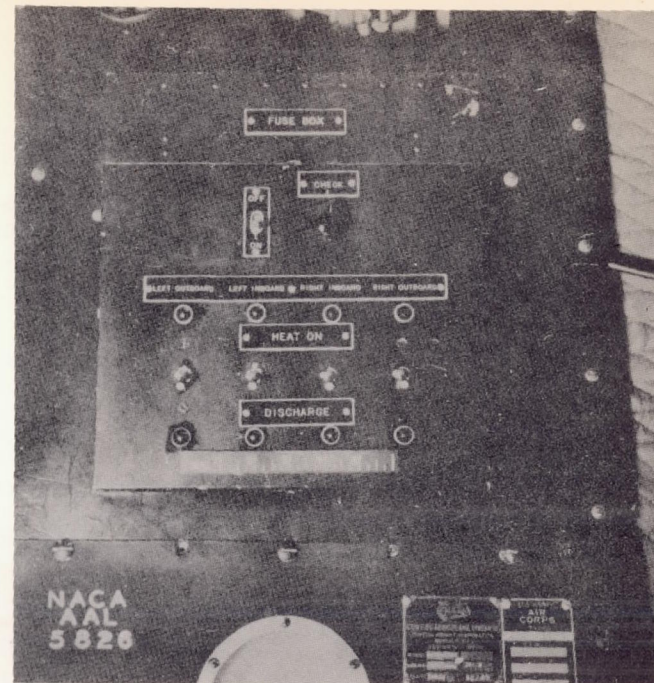
Figure 29.- Control panel for discharge-valve motors of C-46 airplane thermal ice-prevention equipment.

The valves for the operation and regulation of the thermal ice-prevention system will be discussed in the order of (1) those controllable in flight, and (2) those adjusted on the ground and fixed for flight. The four discharge valves at the exchanger air outlets are operated by electric motors which are controllable from the cockpit. The motors are located inside the nacelles adjacent to the valves and the two are connected by a short linkage mechanism through a cut-out in the nacelle skin. The control motor installed in the outboard side of the left nacelle is shown in figure 27. The rated torque capacity of the motors is 70 inch-pounds. A circuit diagram for the installation of the motors is presented in figure 28. Operation of the switch labeled "heat to wing" and "discharge" in the figure causes the motor to drive the valve from one position to the other. The motor is stopped at each limit of the valve travel by a limit switch mechanism attached to the valve arm. The green and amber lights shown in figure 28 indicate the position of the discharge valve, amber designating the discharge condition. The control motors as supplied by the manufacturer were equipped with high-temperature override units, but these devices were not connected into the system for the preliminary performance tests. The discharge-valve control-motor panel, as installed in the cockpit of the airplane, is shown in figure 29.

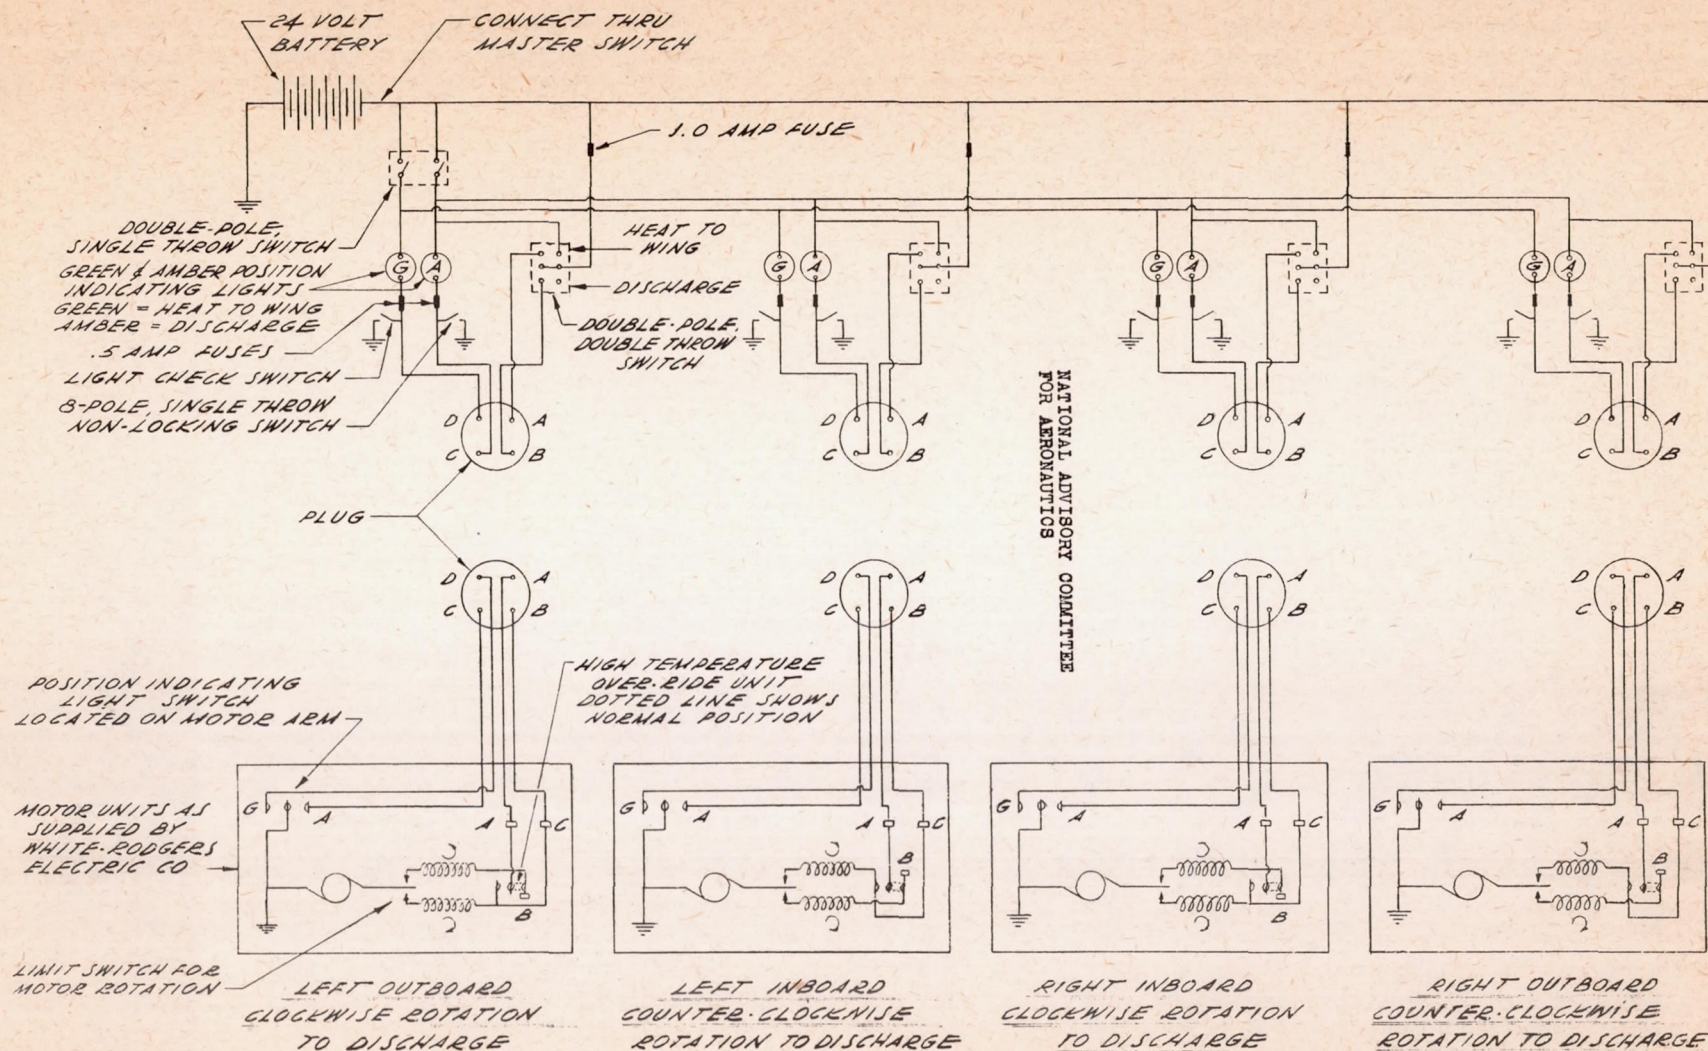
FIGURE 28.- WIRING DIAGRAM OF CONTROL MOTORS FOR DISCHARGE VALVES
LOCATED AT HEAT-EXCHANGER AIR OUTLETS, C-46 AIRPLANE.
